DAMAGE PROFILES IN SILICON AND THEIR
IMPACT ON DEVICE RELIABILITY

Guenter H. Schwuttke

International Business Machines Corporation

1 January 1974

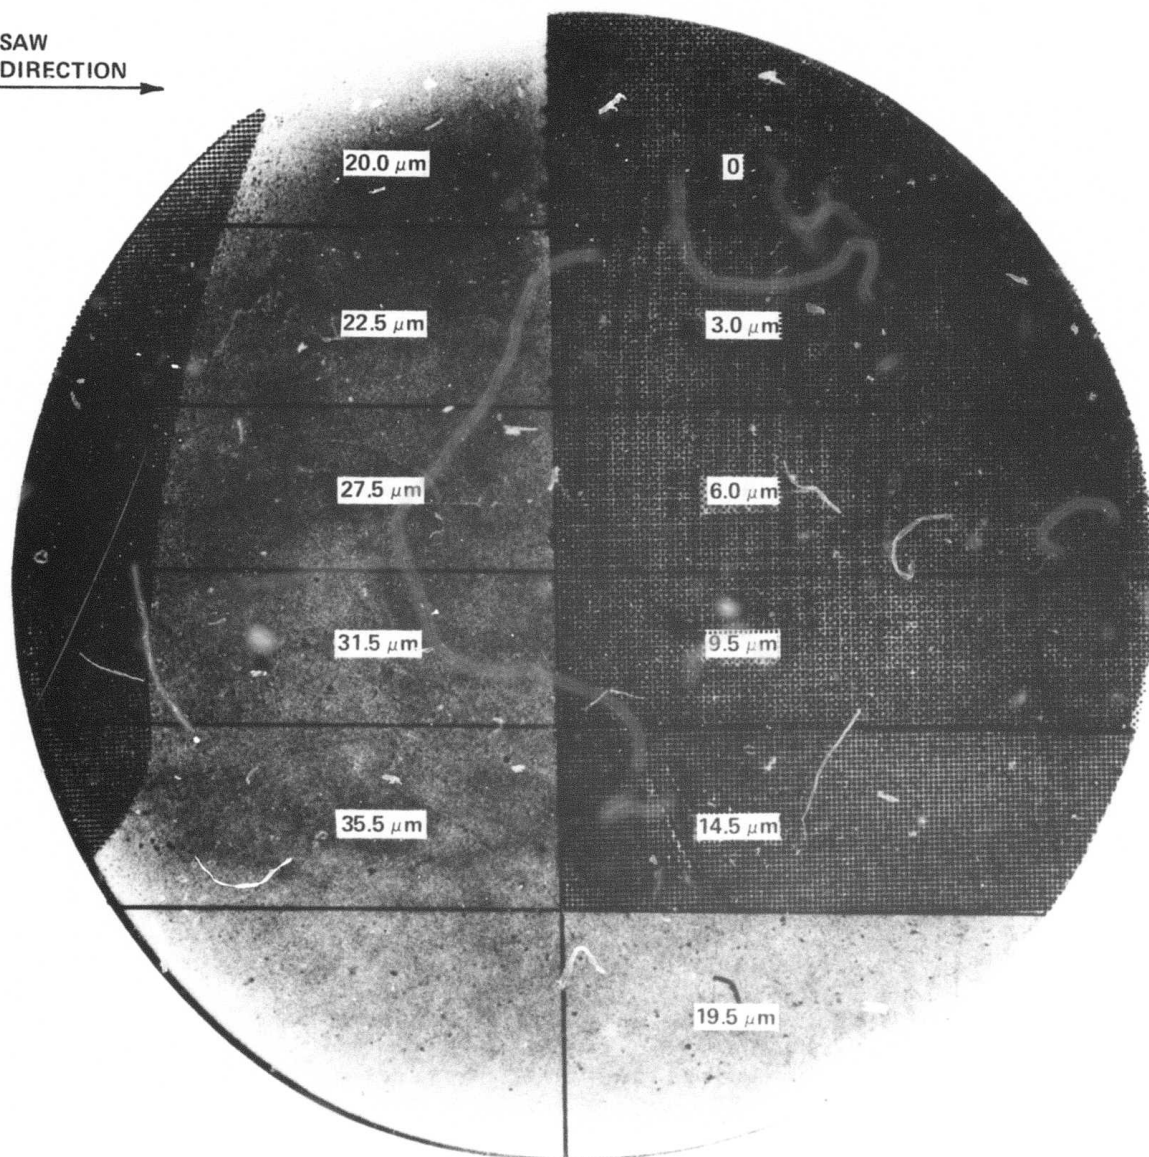
DAMAGE MAP: END B

Fig. 10b. Damage map corresponding to Fig. 10a.

The x-ray topographic images of the A and B surfaces of wafers cut from the end of the crystal are essentially identical to Figs. 7a and 8a and are shown in Figs. 9a and 10a. The nonuniform damage in the A surface (Figs. 9a) has a polished appearance similar to the one shown in Fig. 7a; the nonuniform damage in the B surface (Fig. 10a) consists of striations and edge damage of the type shown in Fig. 8a. The damage map of the A surface is shown in Fig. 9b. The uniform damage is removed after $8.5\mu\text{m}$, and the nonuniform damage is more than $32.5\mu\text{m}$ deep. The B surface map (Fig. 10b) indicates $\sim 9.5\mu\text{m}$ of uniform damage and $35.5\mu\text{m}$ of nonuniform edge damage.

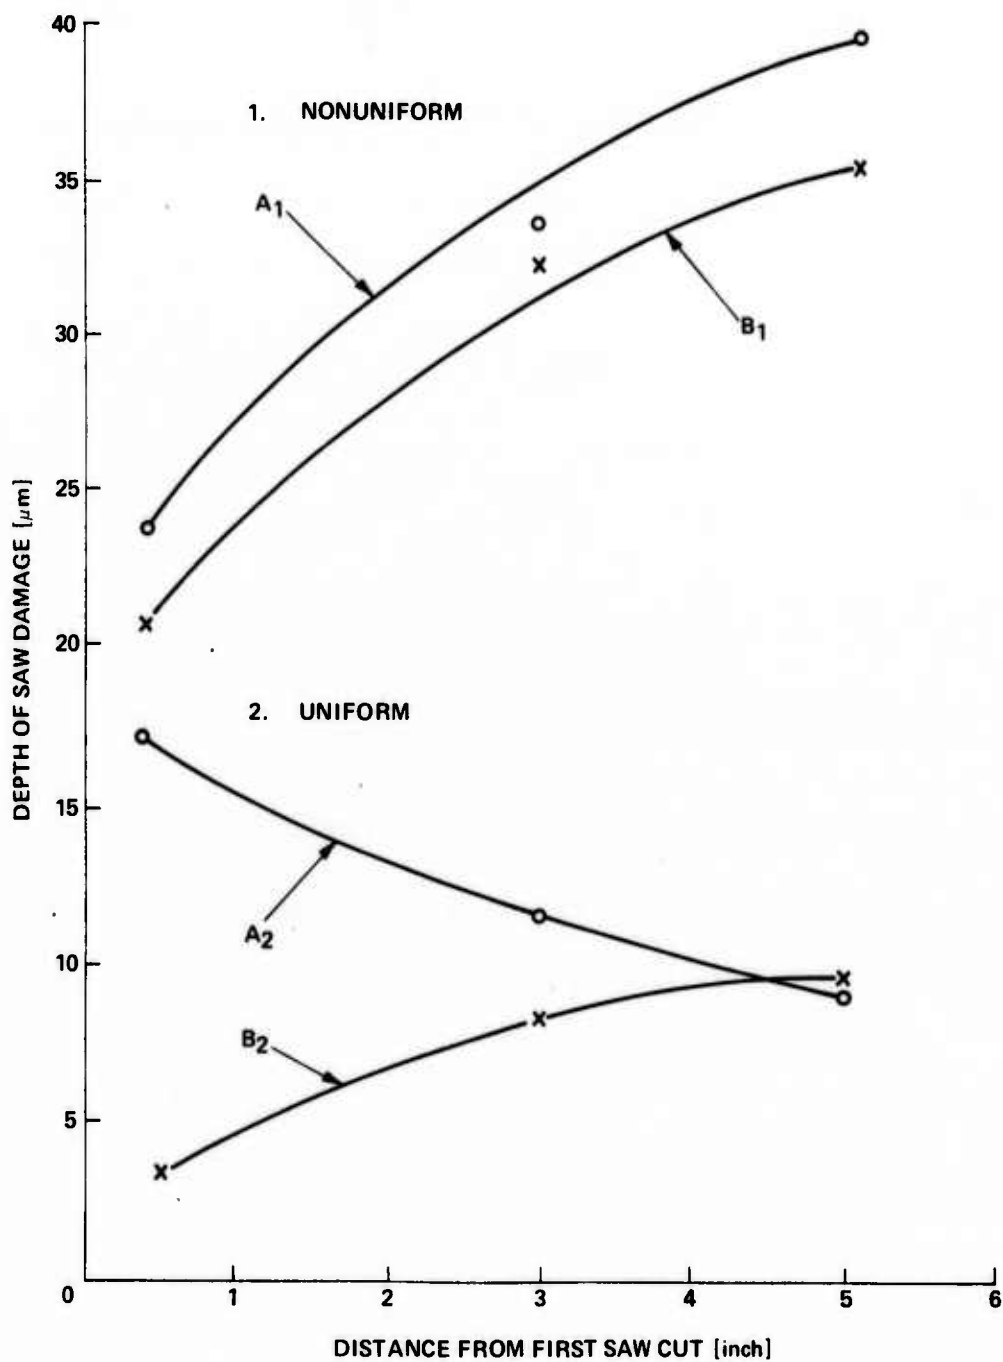
Fig. 11. Damage profiles showing damage distribution after slicing.

1. Inhomogeneous
2. Homogeneous

An analysis of adjacent surfaces (separated by the saw blade during the same cut) permits a good evaluation of the slicing process in terms of saw damage. Such an evaluation is made through damage profiles. The damage profile of the wafer introduced by the sawing process is obtained through recording and evaluating SOT topographs with the help of damage maps of A and B slices taken at various locations along the crystal throughout the complete slicing procedure. Such damage profiles are shown in Fig. 11. Note that the major damage contribution comes from the nonuniform damage mode.

Significant in these profiles is also the variation of nonuniform saw damage depth with wafer position. In this experiment the nonuniform damage in the A surfaces appears higher than in the B surfaces.

Interesting are the damage depth curves obtained for the uniform damage. The uniform damage on A and B surfaces show an opposite trend. The damage in the A surfaces is larger in the beginning and is steadily decreasing while the damage in B surfaces is considerably smaller at the start than in the A surfaces but is steadily increasing. A and B surfaces are approaching the same damage depth of approximately 10 μ m.

Damage profiles as shown in Fig. 11 are not necessarily representative of the state of the art of ID slicing of silicon. However, we have come to the conclusion that ID slicing of semiconductor crystals in general does not get the attention necessary to guarantee a minimum of damage in silicon wafers after slicing. Perfection of silicon wafers after slicing and polishing seems to be more or less accidental. Damage profiles after slicing are unknown and not asked for. Quality assurance of wafers is obtained after polishing and is based on optical inspection of specular surfaces. Such surfaces are classified as perfect but may contain millions of microsplits^{1,2} which are leftovers of saw damage introduced through ill-understood and badly controlled slicing.

Problems listed under (1) are obviously technique and equipment related and, consequently, can be minimized or eliminated if properly understood. Damage profiles as presented in Fig. 11 appear very useful in this respect and are proposed for general application to achieve quality control of the ID slicing process. The inhomogeneous damage distribution in silicon wafers after ID slicing must be reduced to a minimum. This can be achieved as demonstrated by the damage distributions obtained in H-wafers as shown in Table III.

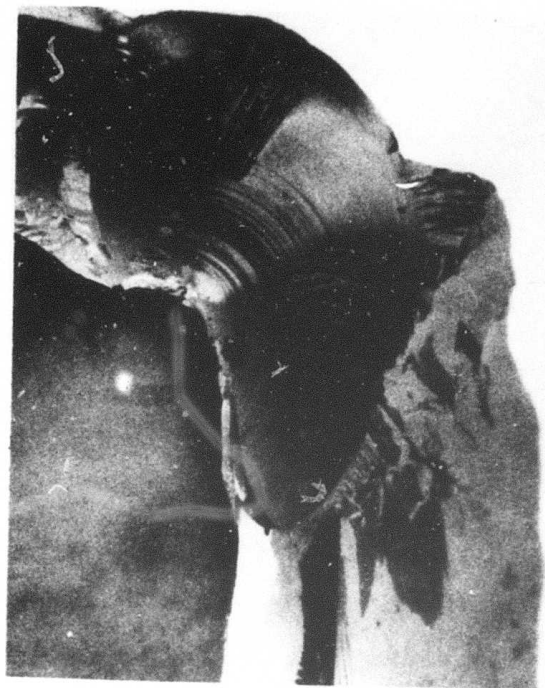
Fig. 1. Partially exposed Hertzian fracture cone in monocrystalline silicon. Ball diameter 22.2mm drop height 63.5cm, slice thickness 10mm. Top view of sample (10.5X).

Hertzian cone fracture patterns were produced by impacting polished silicon surfaces with free-falling, hardened and chrome-plated steel balls. An example illustrating Hertzian fracture cones in Si is shown in Figs. 1 and 2. Such measurements were made using a simple test setup where plastic tubes are positioned vertically above the silicon sample piece as shown in Fig. 3. The tubes served to hold the sample on the base plate and guide the steel balls. The balls were dropped into holes cut into the sides of the tubes (Fig. 4). The equally spaced holes allowed some experimental variation of the drop height. The balls were prevented from restriking the sample after rebound by insertion of a curved rod into a slot at the bottom of the tube. (Fig. 5) This rod also served to subsequently raise the balls to

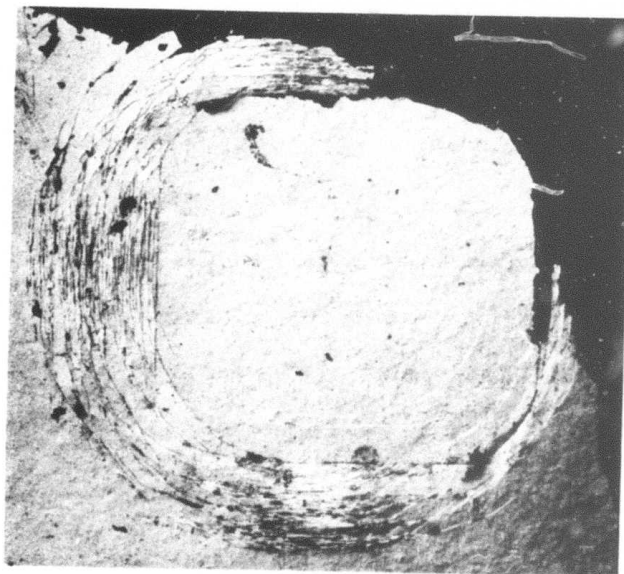
Fig. 2. Close-up of surface ring cracks in sample shown in Fig. 1 (46X).

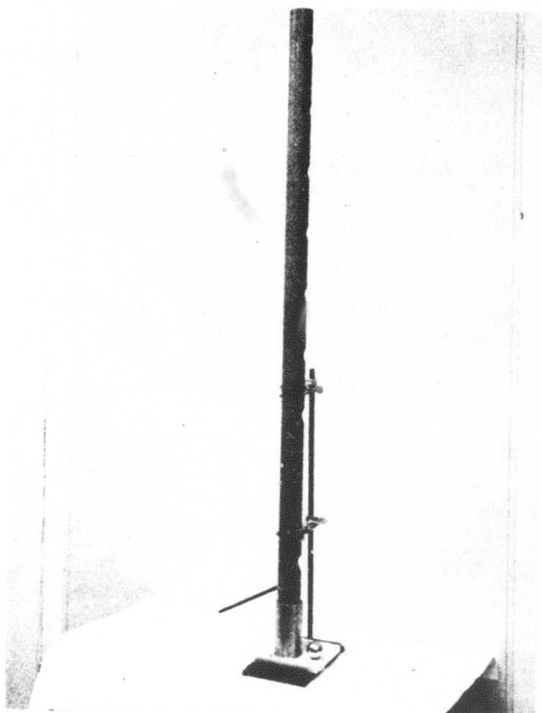
Fig. 3. Drop tube and steel ball for Hertzian fracture cone production in silicon (test slug is shown in place).

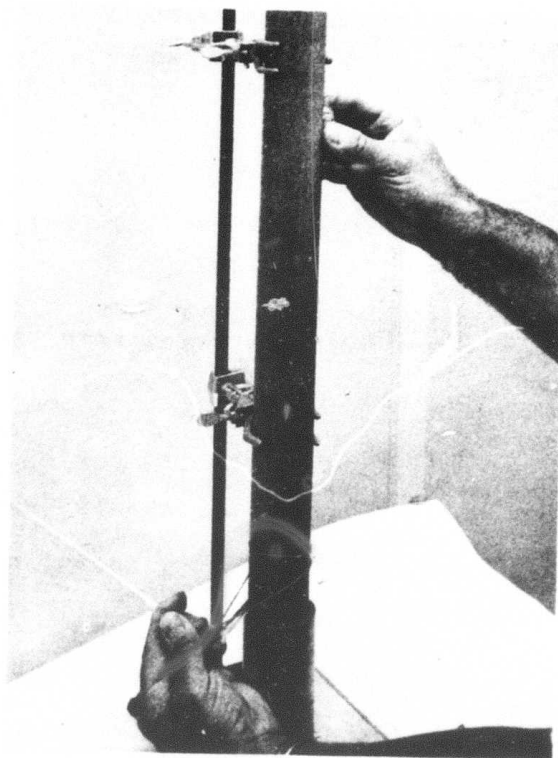
Fig. 4. Fracture cone production in progress.

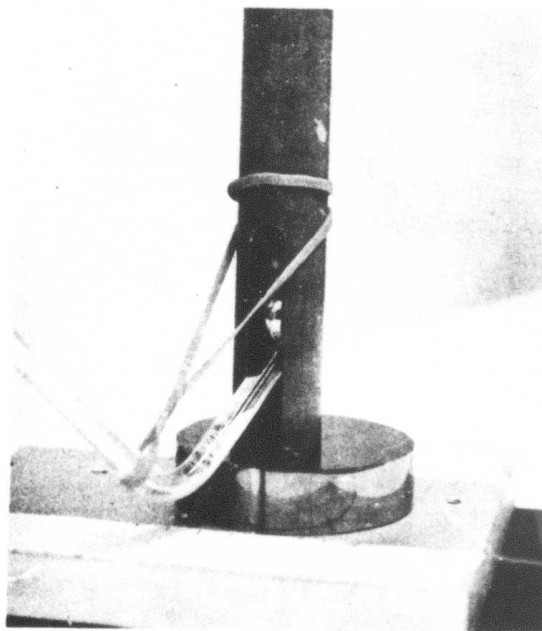
Fig. 5. Means for preventing a second impact after rebound of steel ball.

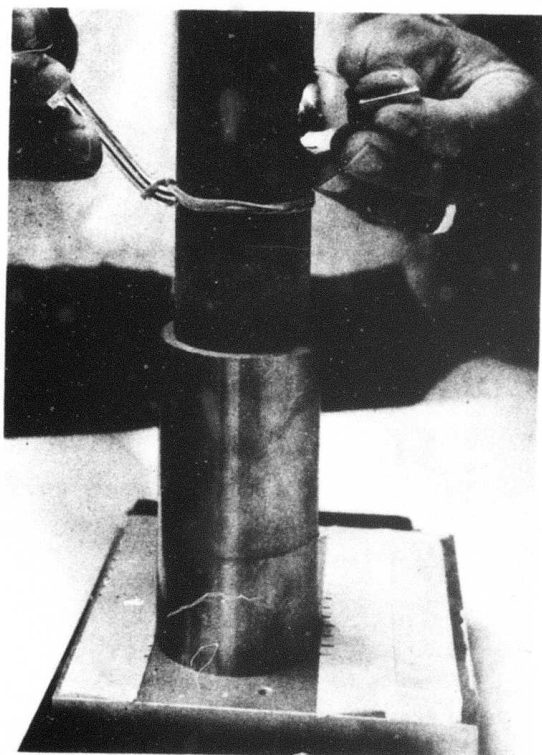
Fig. 6. Method of removing ball from drop tube prior to relocating sample for next impact.

the removal hole where they were taken from the tube by a magnet. (Fig.6) This facilitated repositioning of the sample slug for the next drop. Various size balls with the appropriate tubes were used (Fig.7) to obtain a range of crack sizes.

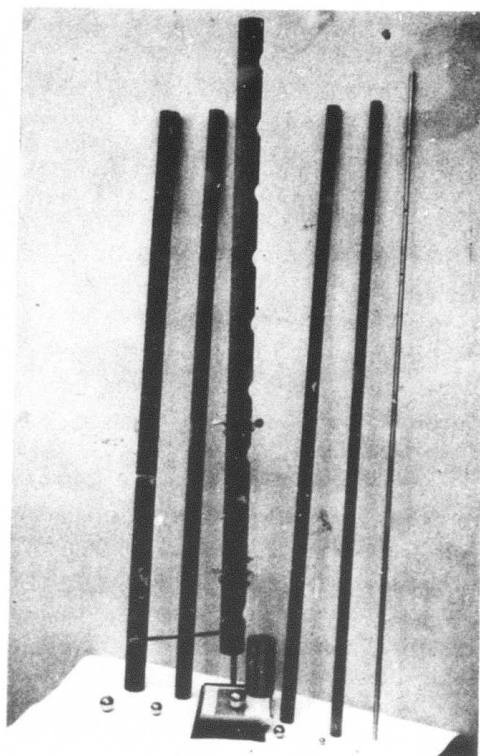
Fig. 7. Various size drop tubes and steel balls for fracture cone production.

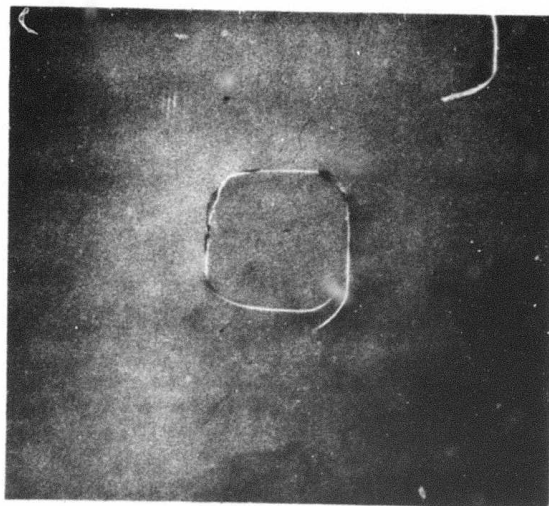
Fig. 8a. Photo micrograph of Hertzian fracture ring in 0.375mm thick silicon wafer, ball dropped 21.6cm (46X).

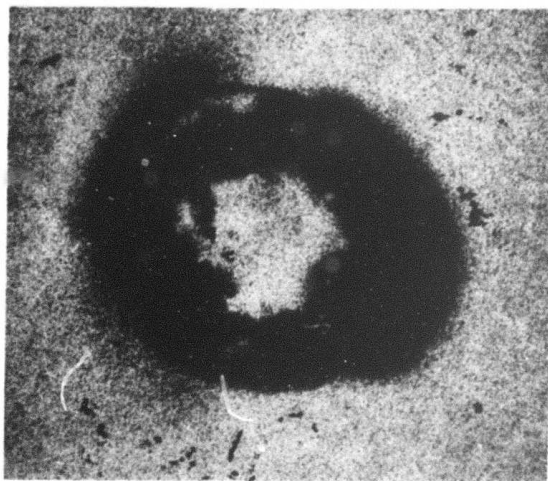
Fig. 8b. X-ray topograph of Hertzian fracture cone shown in Fig. 8a. Note larger dimensions (46X).

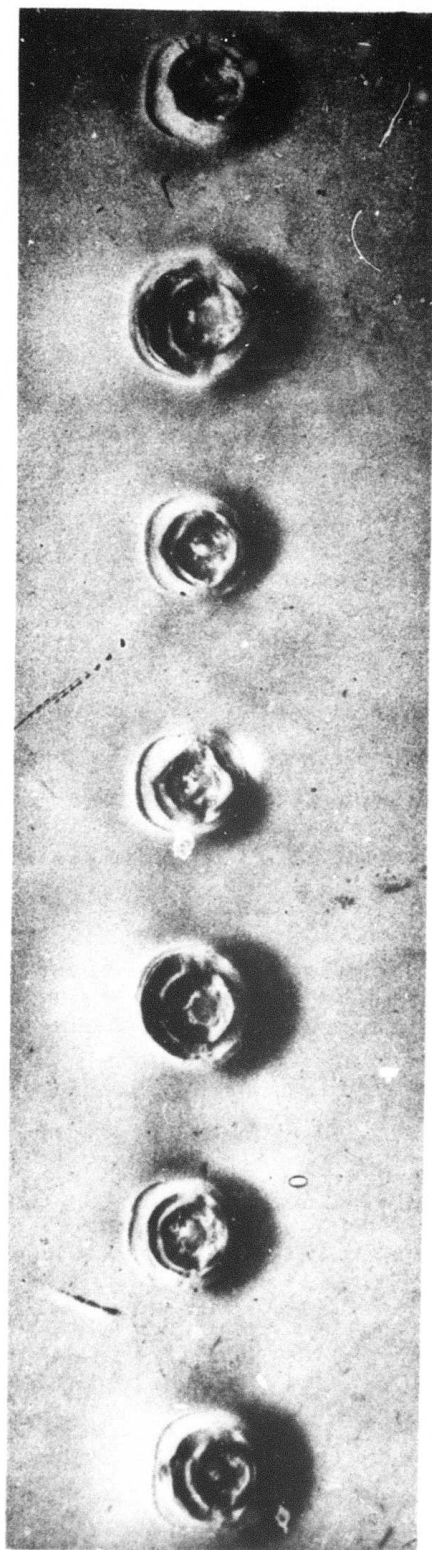
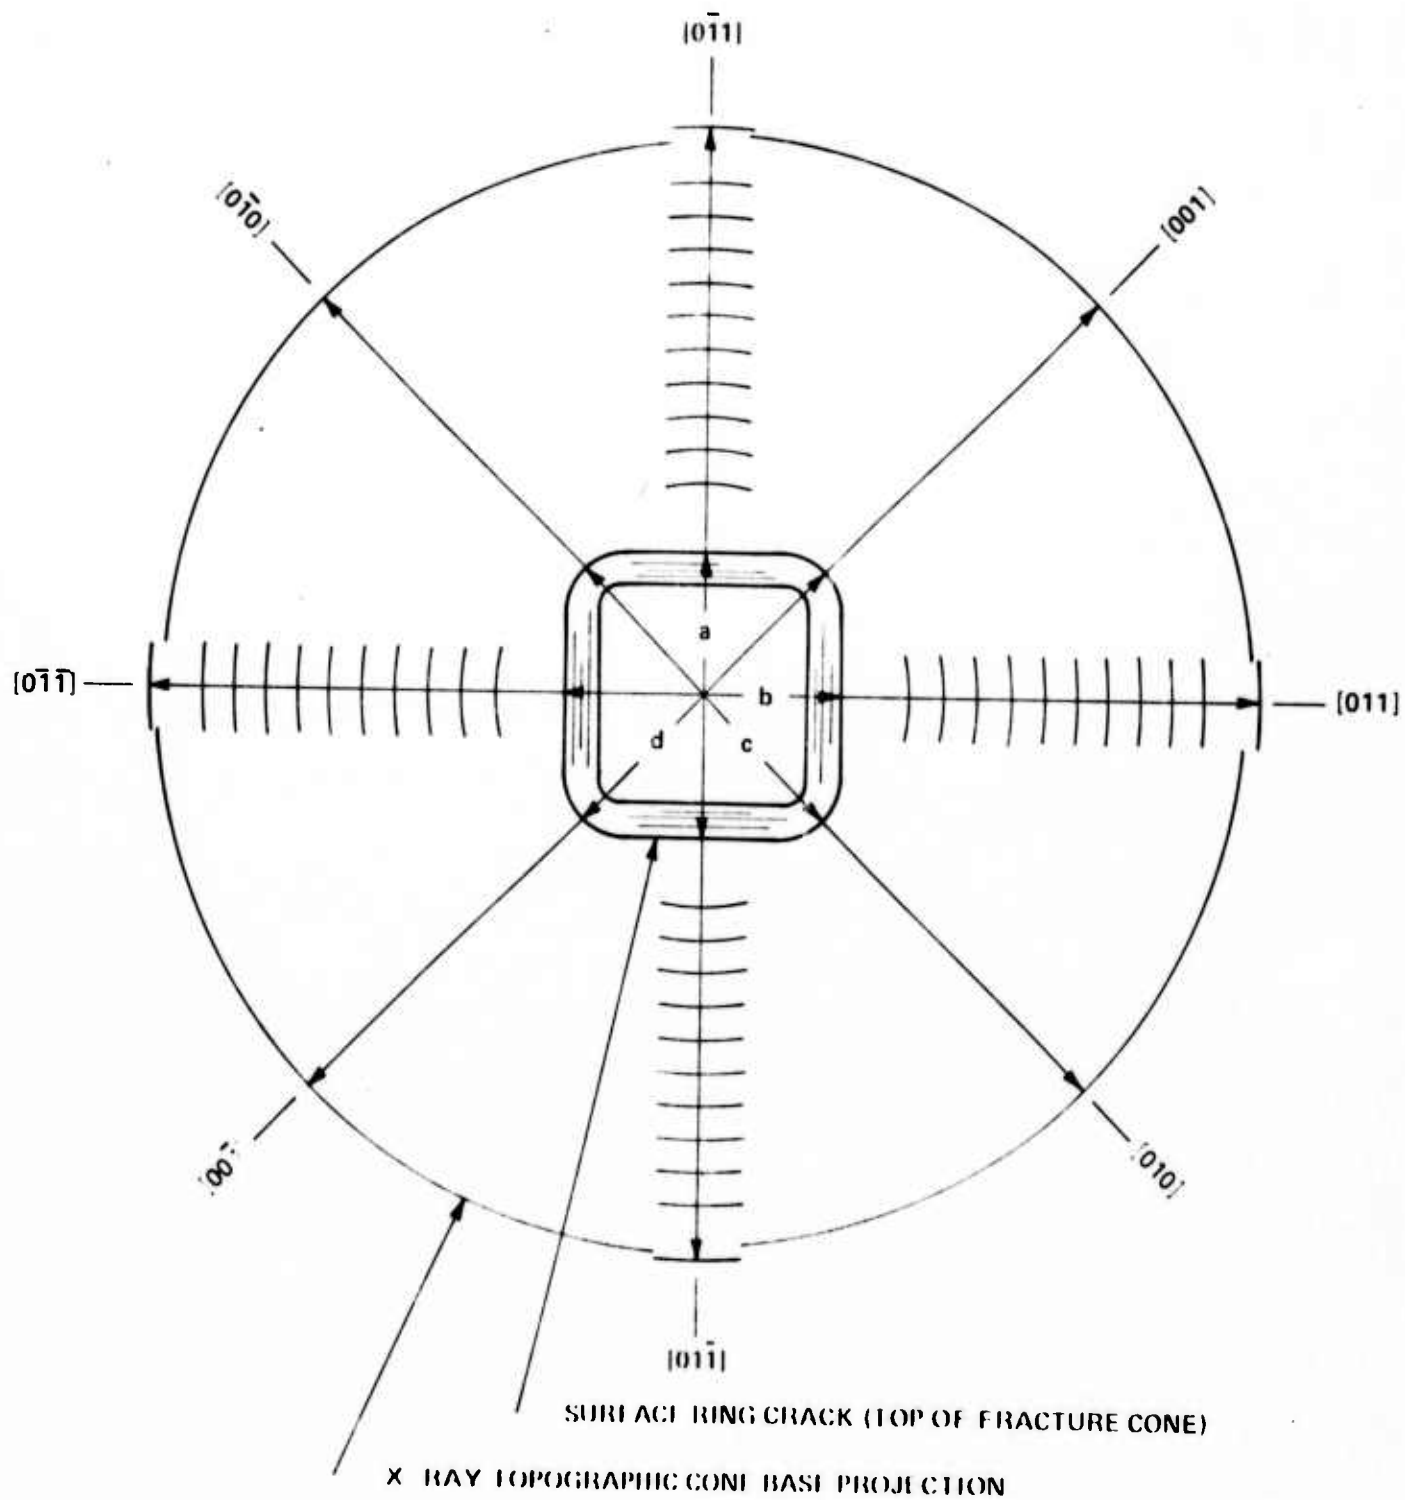
Fig. 10. Measurement scheme for ring crack patterns and fracture cone base projections.

The sizes of surface ring crack patterns and cone base projections, used as indicators of relative fracture strength, were obtained from enlarged micrographs of the samples and enlarged x-ray topographic plates, respectively. The measurements on both were made according to a scheme shown in Fig. 10. The average pattern diameter (D) for the seven fracture cone tops and bases on each test slug was calculated from this data with the expression:
$$D = \sum_{n=1}^7 \frac{(a_n + b_n + c_n + d_n)}{28}$$

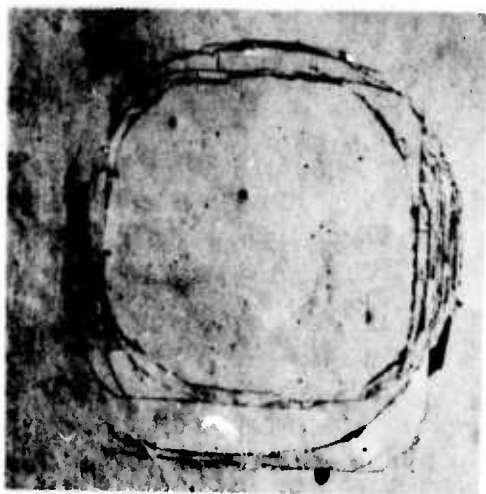
Fig. 11a. Optical micrograph of standard fracture cone produced on tail section (46X).

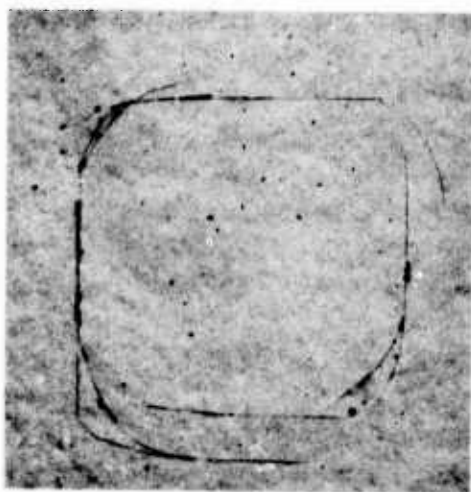
Fig. 11b. Optical micrograph of standard fracture cone produced on seed section (46X).

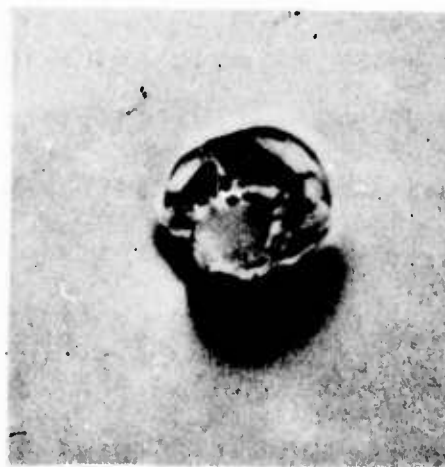
Fig. 11d. X-ray topograph of fracture cone corresponding to Fig. 11b (approx. 10X).
